The Current Status of the Japanese Penetrator Mission Lunar-A

Manabu Kato, ISAS/JAXA

Lunar-A mission

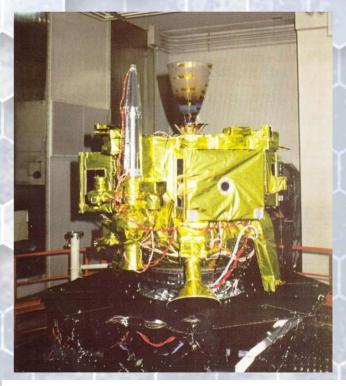
Lunar-A spacecraft and penetrator

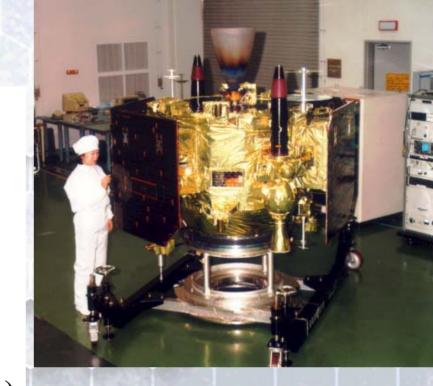
Spacecraft

- Attitude control: Spin-stabilized, 6 rpm,
- Thruster: 20N RCS x 6, 1 N x 4
- Diameter: 2.2 m, Height: 1.7m
- Wet mass: 540 kg (Fuel: 190 kg)
- Telecommunication: S/C-PNT via UHF band (128 bps-2 kbps)
 S/C-UDSC DSN via S band (8 kbps)

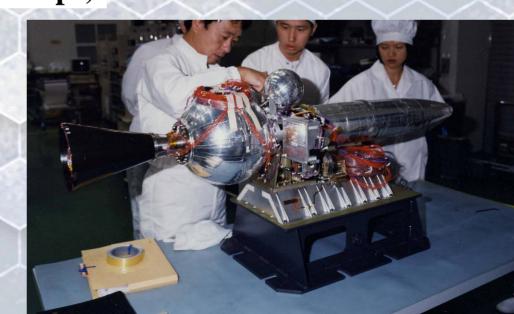
Penetrator

- 1.5 m length
- 45 kg weight /probe,
- attitude control and deorbit motor

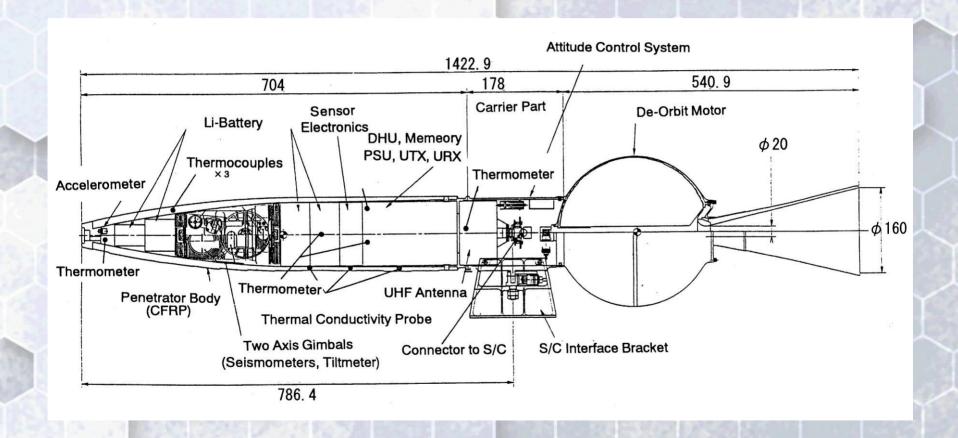
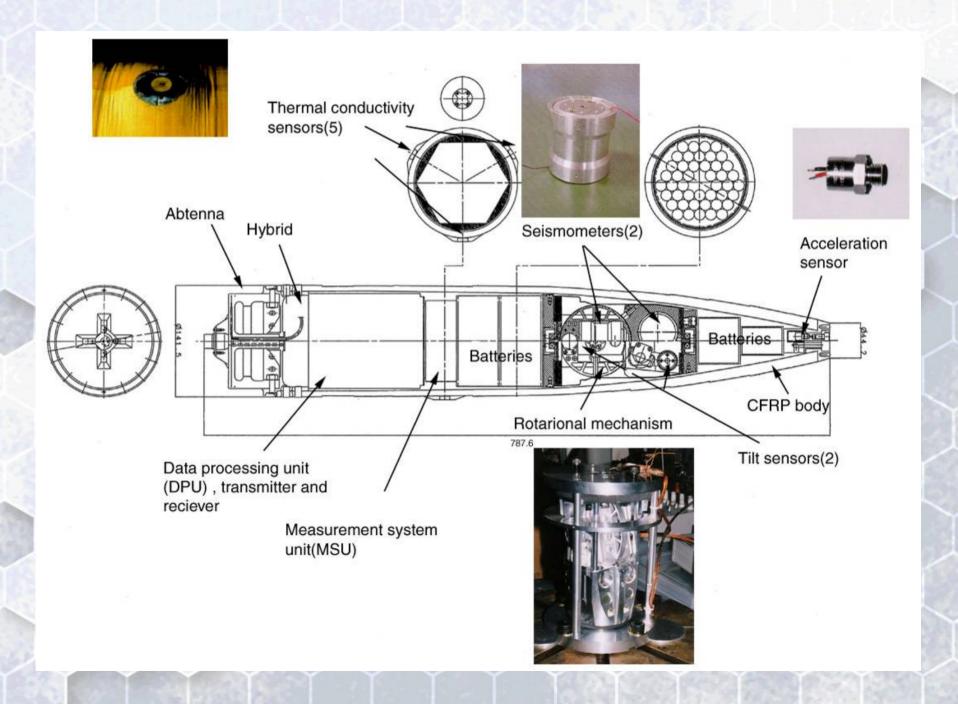
Lunar-A Penetrator Module

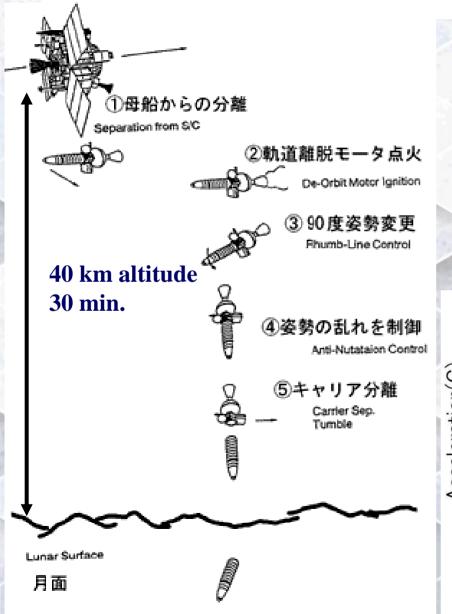
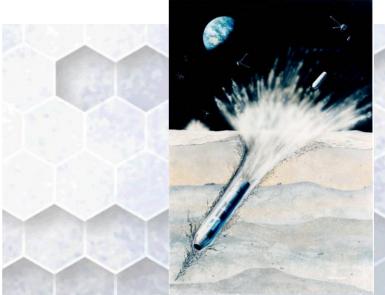
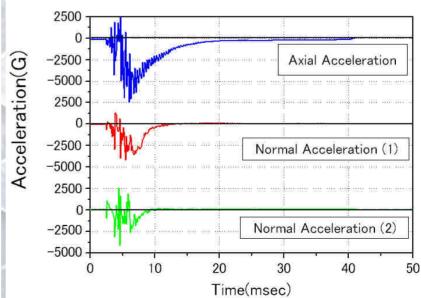
Deployment Sequence of Penetrator

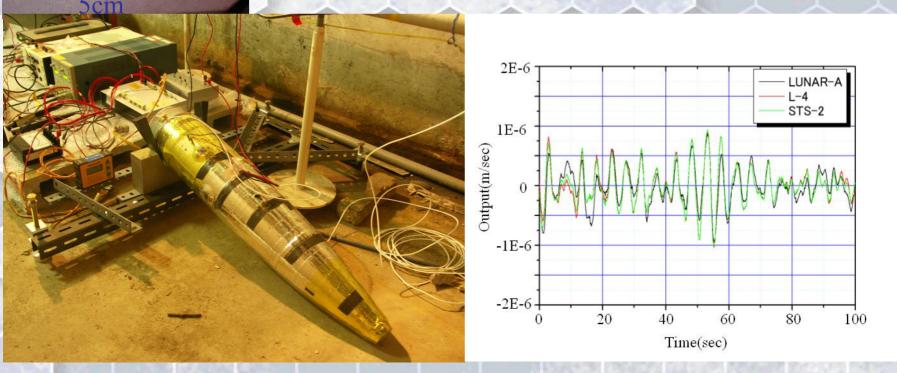
Shock durability of the scientific instruments (1): Seismometer

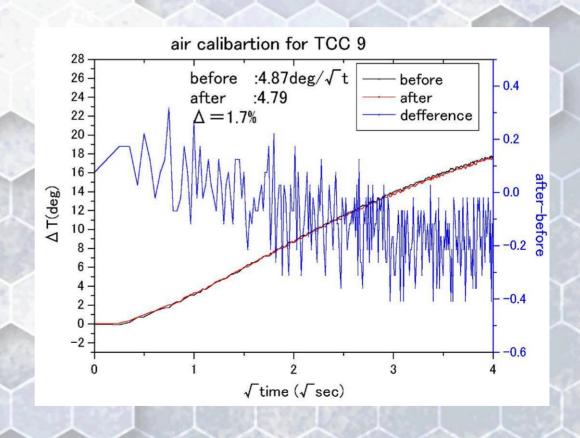
Shock durability of the seientific instruments(2): Thermal sensors

Before penetration

After penetration

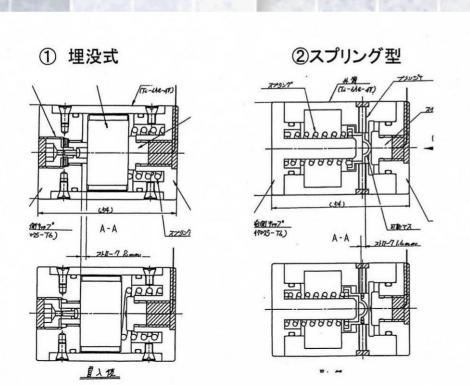
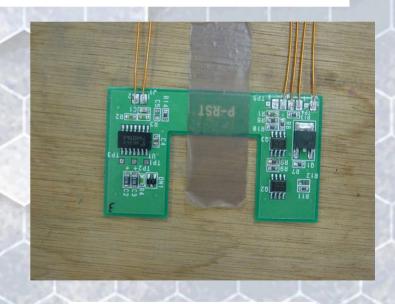
Development of the back up system

- "Reset sensor": mechanical switch triggered by the deceleration force at the penetration
- Timer power off circuit: disconnection of power supply of CPU for about 600 msec

Mass: 200g

Dim. ϕ 36 \times 54

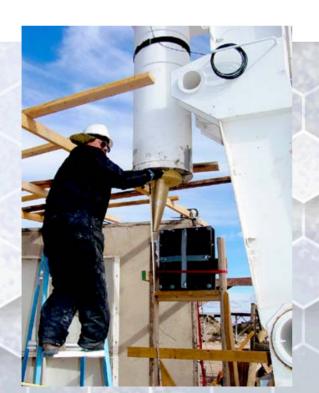
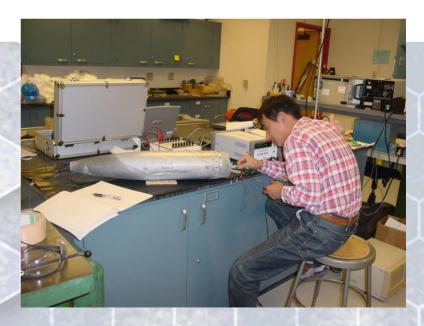
The #1 experiment (Nov/2005)

- 8 "reset sensor" s and 2 electronics circuits were tested.
- Some electronics parts in substitution for the discontinuance products were also tested.
- All the sensors, circuits, and elec. parts worked completely after the penetration experiment.

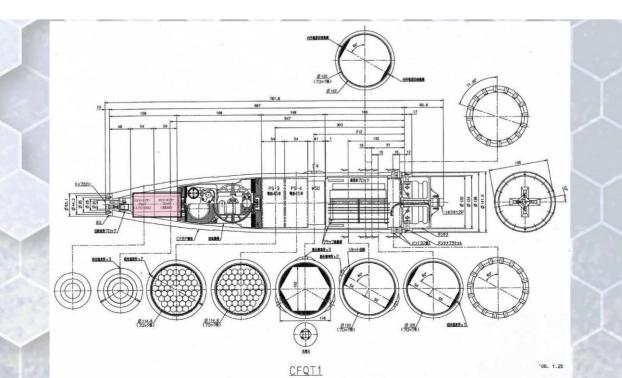
The #2 experiment (June, 2006)

- Fully integrated / power on status.
 - Some modification of DPU for robustness of ESD protection.
 - Two reset sensors + one circuit for back up system.
- Change in experimental procedure for avoiding ESD input.

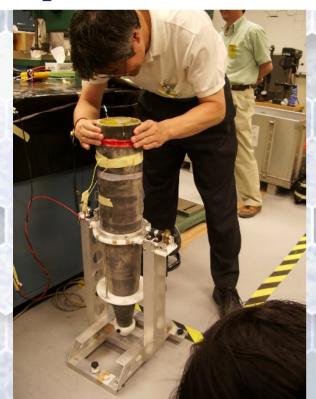
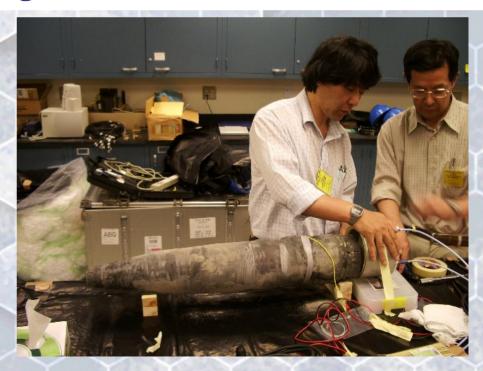
Results of the #2 experiment (June, 2006)

- Successfully communicated with the penetrator after the exp.
- All the functions of instruments work well.
- Detailed examination of instruments and evaluation of sensor performance are now ongoing.

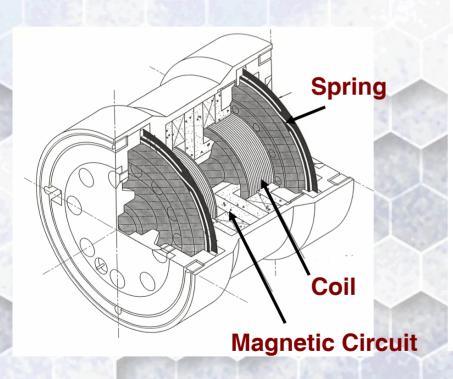
Lunar-A Seismometer

Sensor Size: 50 mm x 50φ

Sensor Mass: 0.35 kg

Electronics: 0.52 kg

Gimbals: 2.30 kg

Power Consumption:

40 mW (monitoring period),

175 mW (measuring period)

Eigen Period: 1.0 ∽1.2 Hz

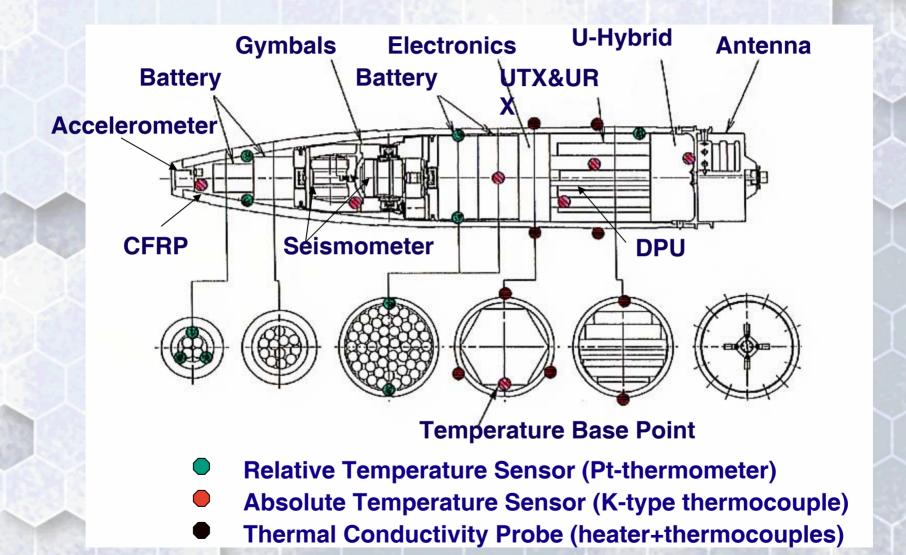
Lunar-A Penetrator Structure
